# **KOOTENAI DEVELOPMENT IMPOUNDMENT**

**LIBBY, MONTANA**

## **SAFETY PROCEDURES MANUAL**

Kootenai Development Impoundment Dam  
May 25, 2005 Inspection

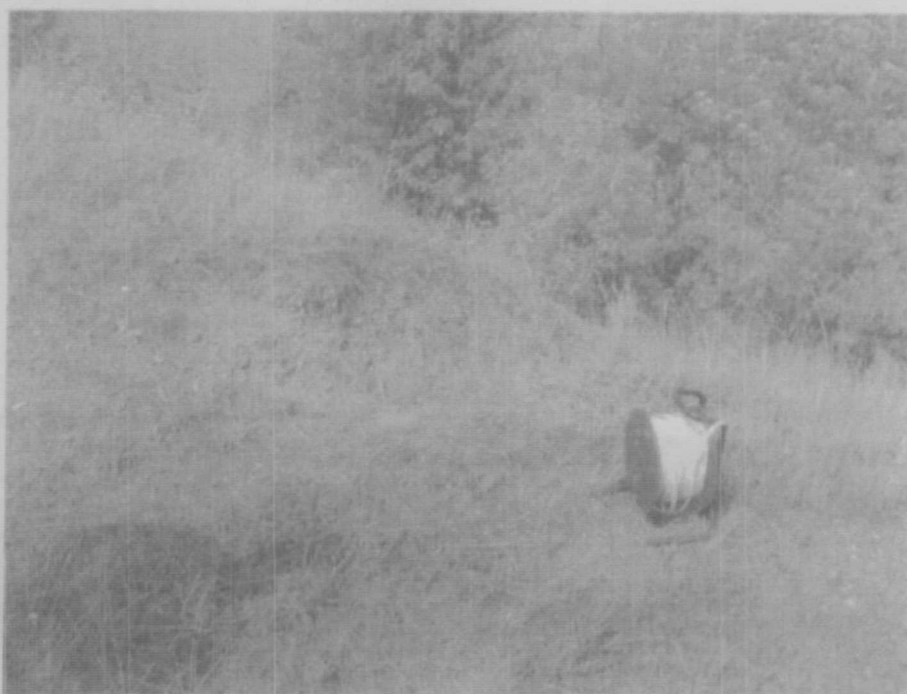
Photograph #3 – Small Erosion Rill – Upslope Face (near P5)

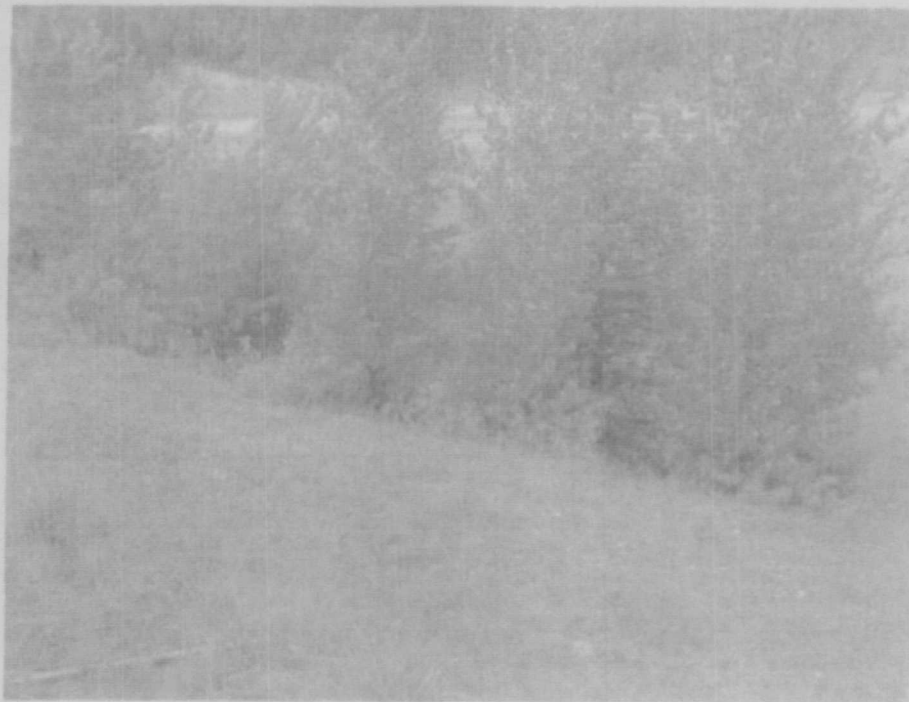
Photograph #4 – Shrub/Tree Growth – Upslope Face

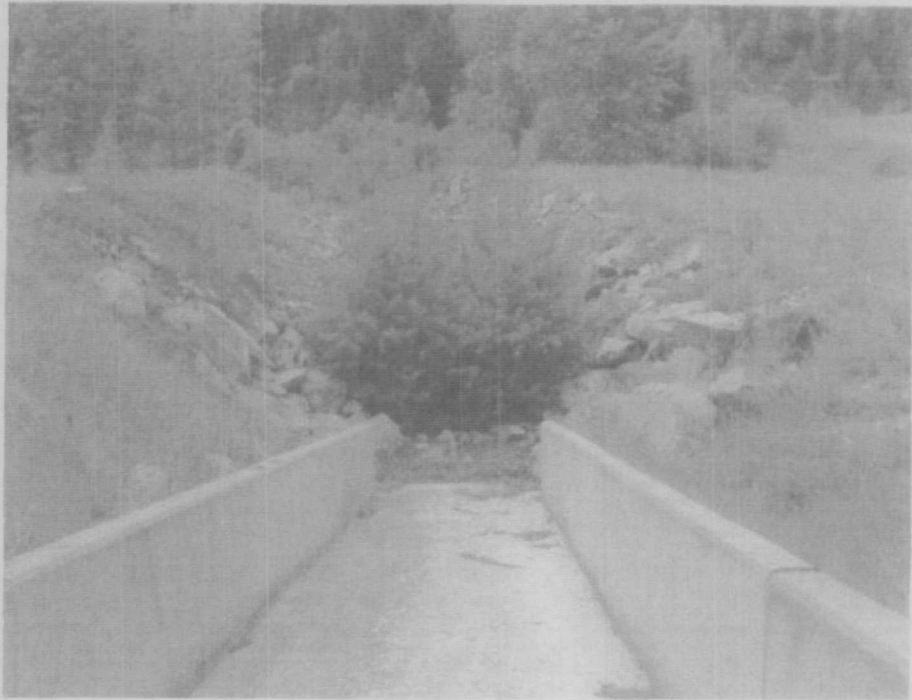
Photograph #6 – Cottonwoods in Energy Dissipation Pool

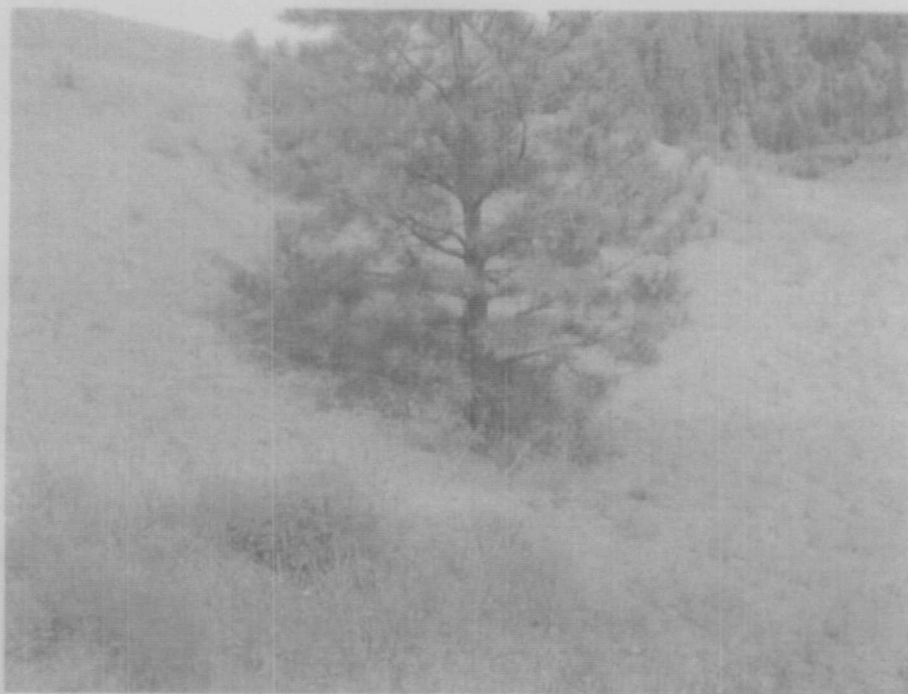
Photograph #9 – Larger Pine Tree on Down-slope Face

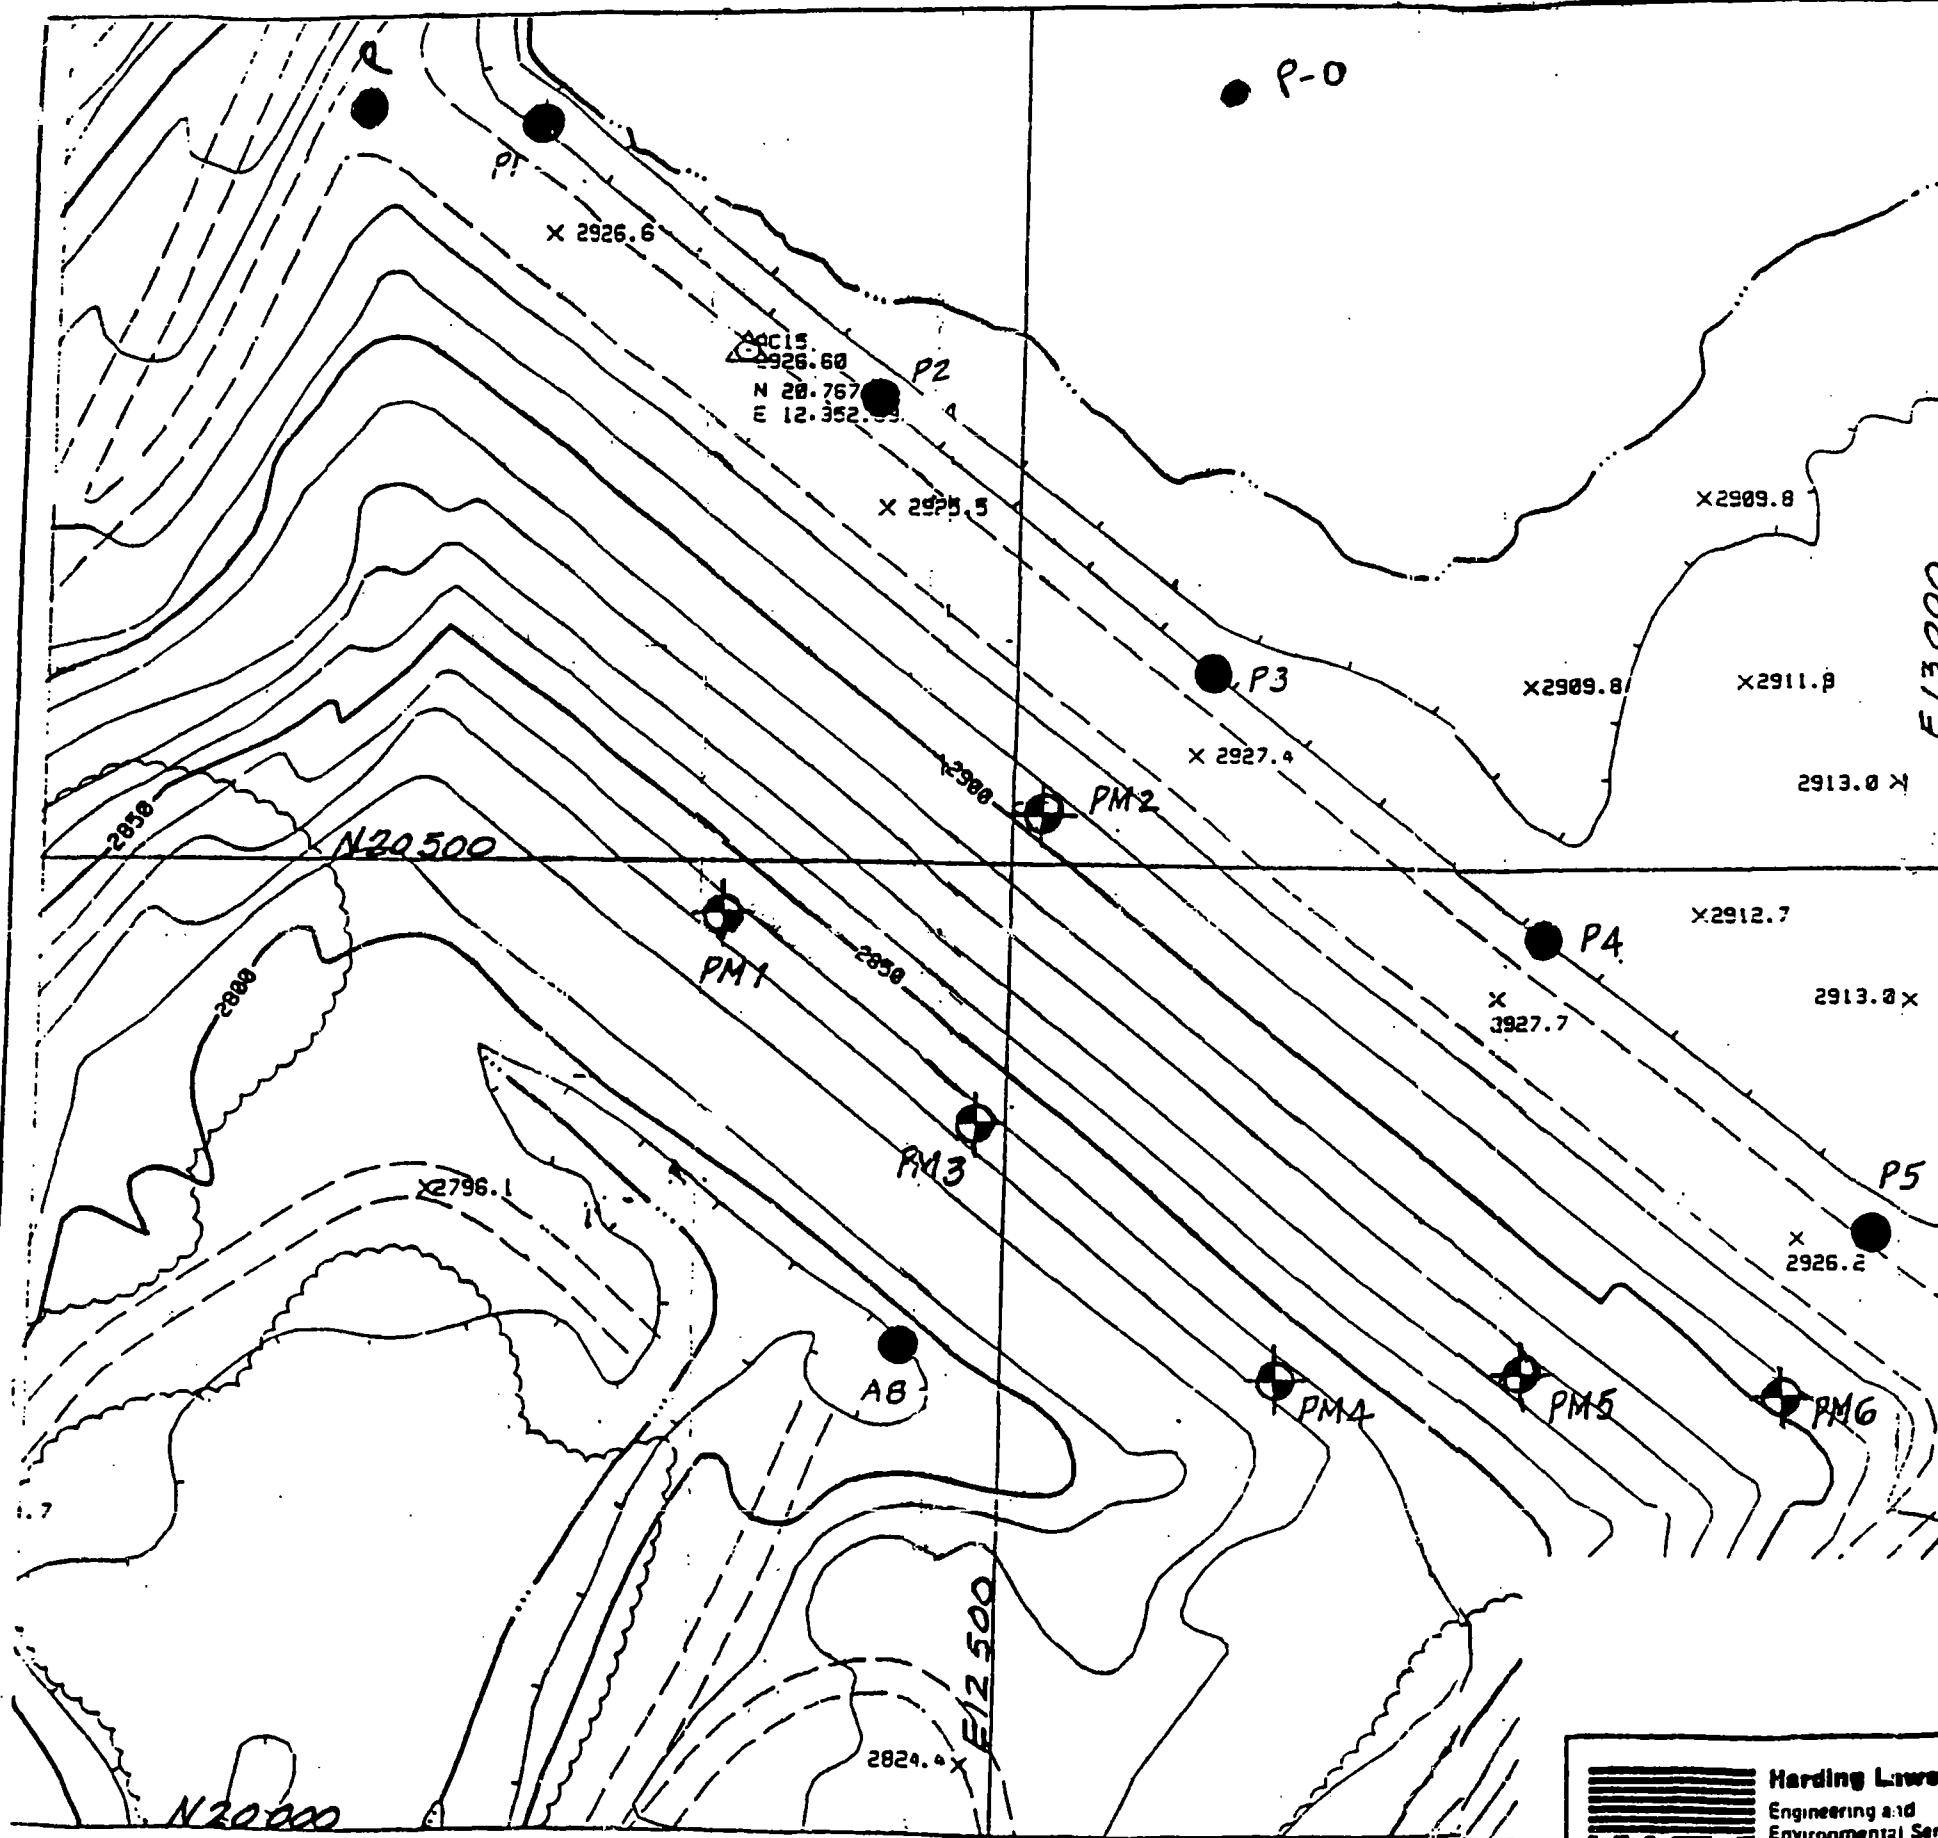
- P1 - Location of previously installed piezometer
- ⊕ PM1 - Recommend location of additional piezometer for monitoring downslope face of embankment
